P. T. INDOCEMENT TUNGGAL PRAKASRA, TBK

Cooling Tower Improvement: Revised Fan Procedure, Regular Cleaning, Float Valve Repair

SUMMARY OF THE OPTION

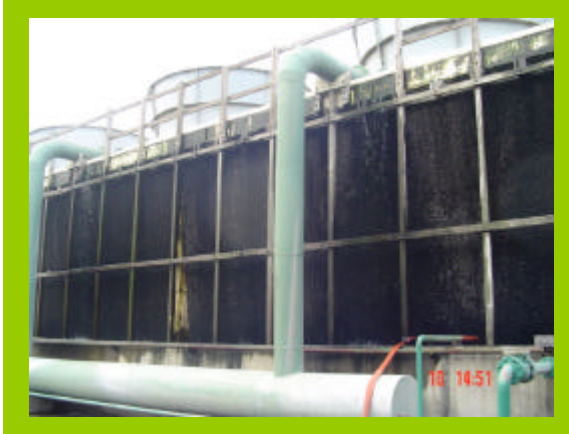
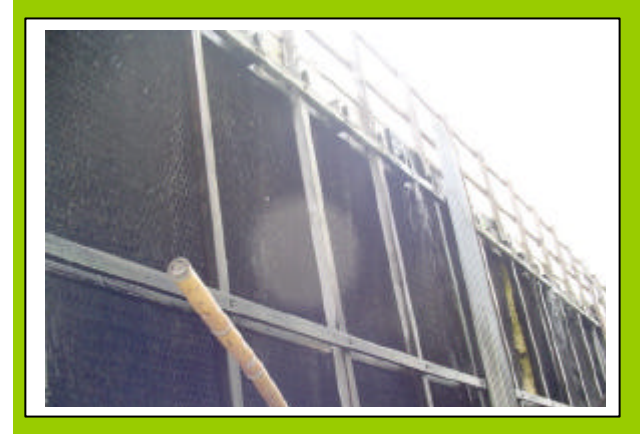
Figure 1. Cooling towers

During the in plant assessment, the cooling tower was inspected and it was observed that two out of four cells are idle, i.e. with no water flowing through them at all, with the fan of each cell running continuously. The flow control valves to all four cells were opened. Yet the two cells on either side of the tower were running dry. The Team was informed that this is a normal operating procedure regardless of how many boilers or turbines are online. At the time, both the turbines and five out of nine boilers were online.

The cold-water basin was overflowing continuously, indicating a failed fill valve. Chemical (Biocides and corrosion inhibitors) are continuously injected at the preset rate with no feed back control regulating their flow. The point where the chemicals are injected into the cold-water basin is adjacent to an overflow point of the basin's water into drain. It is suspected that the excessive algae growth throughout the tower may be due to wasting of a large proportion of biocides in the overflowing water. The PVC fill and side louvers are coated with a thick layer of cement dust.

- During the reparation, the Cooling Tower was not yet completed, therefore the regular cleaning of the tower using hypochlorite and repairing or replacing fill float valve to minimize water loss was not implemented.
- Presently, the Cooling Tower is not in good condition, where two out of four cells in the Cooling Tower is exhausted / damaged. Moreover, one of the material cells inside the bars is missing. Therefore the procedure for Cooling Tower operation efficiency needs to be revised, even though the efficiency can still be monitored by switching off one of the fans, when only

three to four boilers are operating. Cooling Tower repair can only be done when the plant is shut down, which will need 10 days. The reparation costs were being calculated at time of writing of this case study.

- A detailed review of the required number of tower cells to be maintained on line under different operating conditions needs to be addressed. Under the above conditions, it was obvious that two cell fans of the idle cells could be switched off to save electric power (a simple no cost solution).

- Regular cleaning of the tower (once per three months) using hypochlorite to remove algae and cement dust will be necessary. This will eliminate any microbial hazard to all personnel at the plant and will improve the cooling efficiency at the tower, as well as to safeguard plant equipment that requires cooling water from excessive fouling on heat transfer surfaces.

- Repairs of the fill float valve will be required to minimize water loss due to basin overflowing.
- An investigative study of using in-ground-source heat pumps (IGSHP) in-lieu of cooling towers may be an option in the future (when the cooling tower is worn out and due for replacement or extensive refurbishment).
