PT SEMEN CIBINONG TBK

Compressed Air Leak Survey and Leak Repair

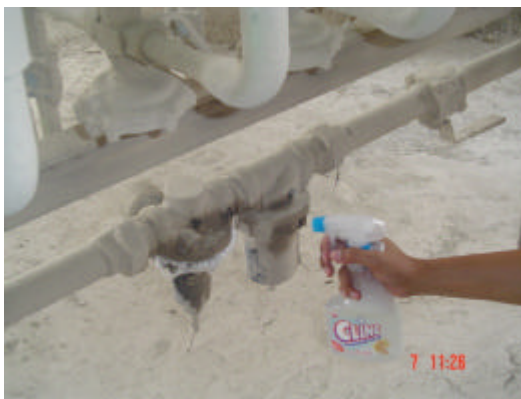
- Carrying out the survey, using the following steps:
 - Soap solution is sprayed on equipments, pipe lines, ducting etc. In the event of a leak, air bubbles appear

Figure 1: Soapy method

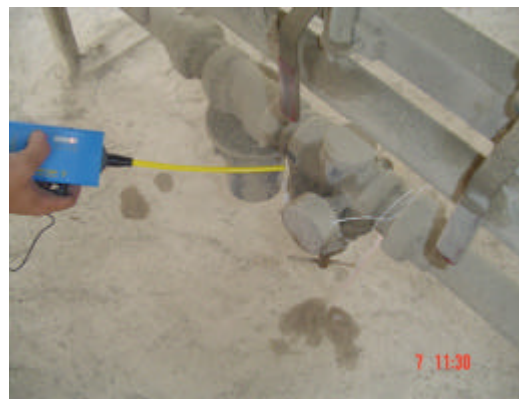
Figure 2: Sound leak detector method

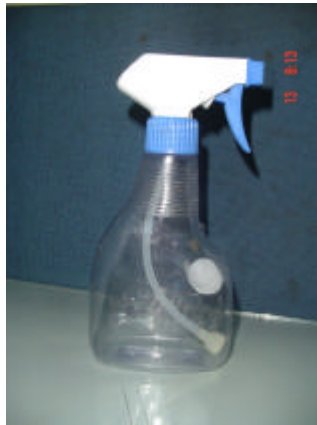
- Soapy solution (water and soap) in a sprayer
 - Plastic tags to label identified leaks
 - Marker to write on the plastic tags
 - Form to fill out the leak number, location, description and estimated size

Figure 3: Sprayer

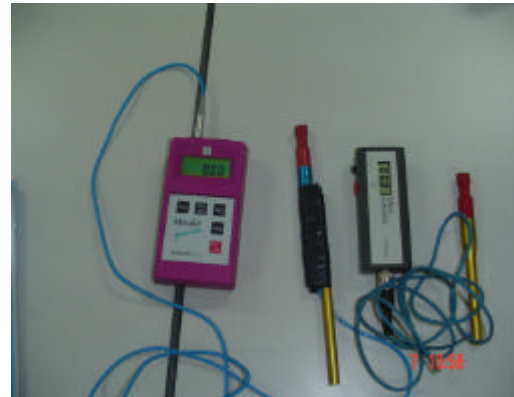
- Because flow meters, The size of the leak is measured using a modified anemometer that measures the amount of air flow from the leak. Sometimes leaks were in locations that were difficult to reach with the anemometer, in which case the size of the leak was estimated by comparing the size of air bubbles with those at leaks that were measured

Figure 4: Anemometer

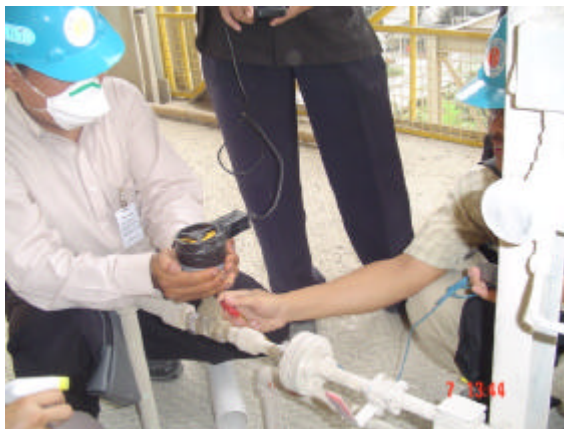
Figure 5: Leak measuring

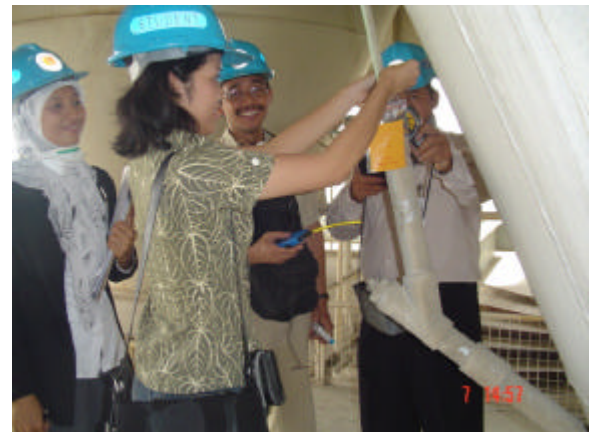
- The leak is marked with a plastic tag
- Calculating the power loss (in kW) based on the measured air leakage and references in the Air Compressor Installation Guide (published by Atlas Copco 1st edition 1996)

Figure 6: Marking of Leak
